Building Envelope Assessment

**The Vogue
124 3rd St W
North Vancouver, BC**

**June 9th, 2009
File No. 5038**

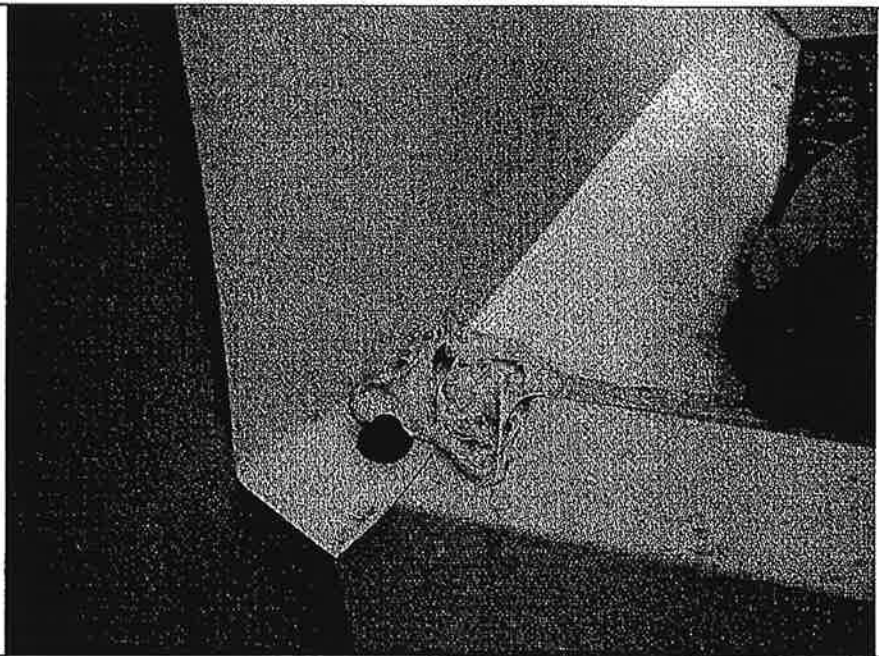
Photo 5

- A gumlip flashing along the West facing firewall was found to have poorly installed sealant and not completely adhered to its substrate (Photos 5-8)
- A flashing on the East foundation wall was found to be damaged and should be repositioned (Photo 9)
- Typical staining on the cladding due to rainwater runoff from the balconies with no provision for rainwater management (Photo 10)
- Some minor damage and cracks in the foundation wall should be patched and repainted. These areas do not appear to cause any water ingress into the structure (Photos 11-13)
- An interior standing pipe in the East stairwell was found to be unfinished around the pipe penetration into the adjacent wall (Photos 14-15)

- Remove and reinstall caulking on gumltp flashing on the West facing firewall (Photos 5-8)
- The metal flashing on the East foundation wall was found to be damaged and should be bent back into its correct position (Photo 9)
- Repair and repaint cracks and spalled concrete found on exterior face of foundation wall (Photos 11-13)

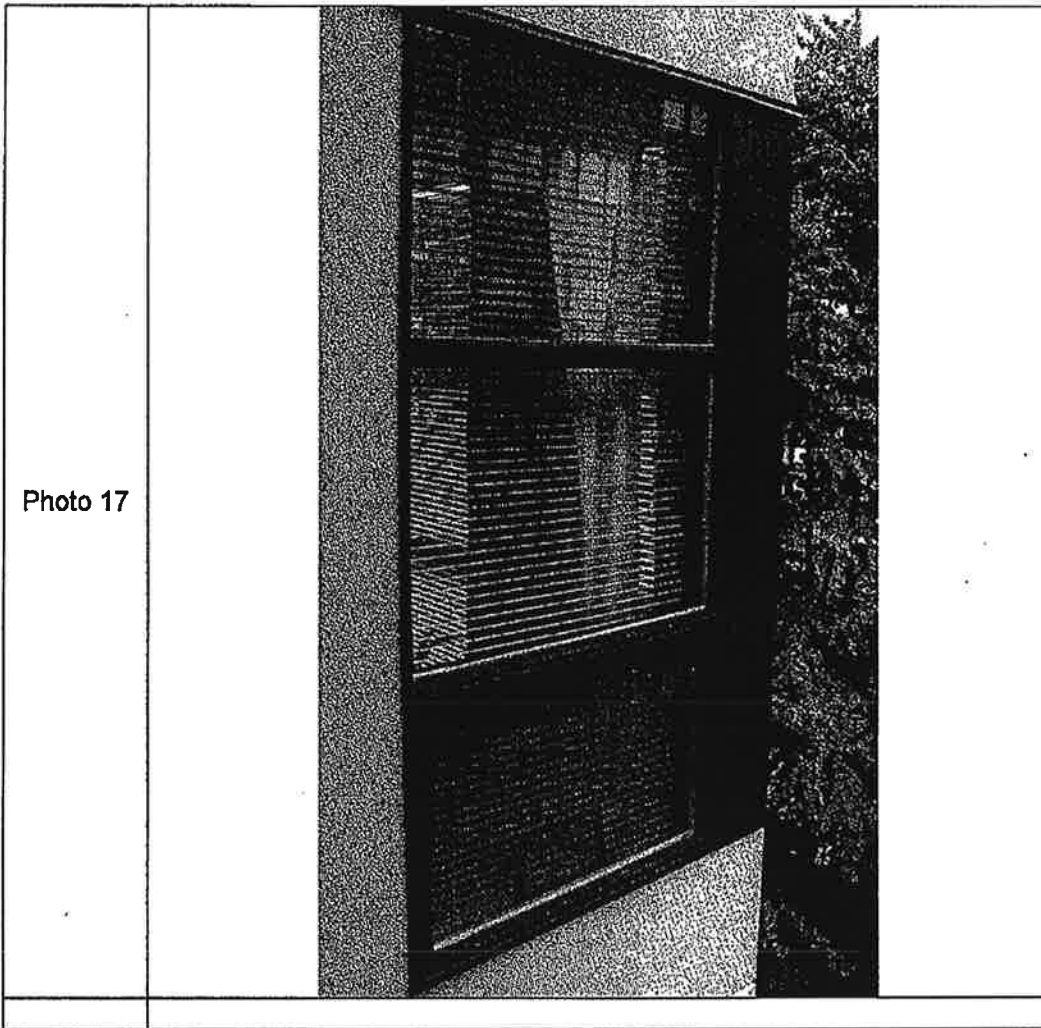
Photo 17

units. There are head flashings, however no sill flashings around the windows or doors to direct water from the assembly transitions (Photos 16-17). Sill flashing was not a building code requirement when the building was designed. Properly installed head flashings direct water away from the cladding at the window opening at the top of the window. Sill flashings direct water away from the cladding face that flows down the outside of the windows. All windows investigated appeared to be functioning adequately with no failed IGU's. Windows of this configuration have a service life of approximately 20-25 years dependent on various factors. According to the observed data on the building plans, these windows are approximately ten years old. Additional observations at and around the windows or doors include the following:

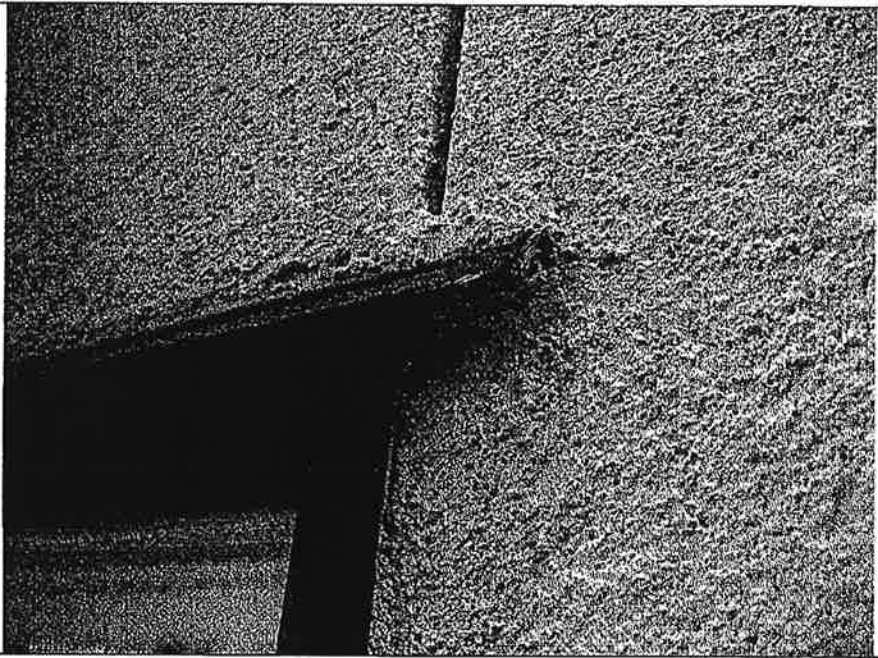
Photo 18

- The stucco cladding terminates tight against the window frames not allowing for expansion and contraction of the two different building materials. The building code mandates that a caulk joint is required between dissimilar materials (Photos 18-19)
- A dry gasket on removable glazing stop was found to be damaged at one location on Unit #509's living room window (Photo 20)
- A piece of jagged metal was found at the sill of a window adjacent to the South patio walkway (Photo 21)
- The sill trim on most patio sliding doors should be repainted (Photo 22)
- The adhered membrane flashing at the sliding door sills are typically failing and bleeding onto the balcony vinyl membrane. This may be due to inadequate detailing or incompatible membranes (Photos 23-24)

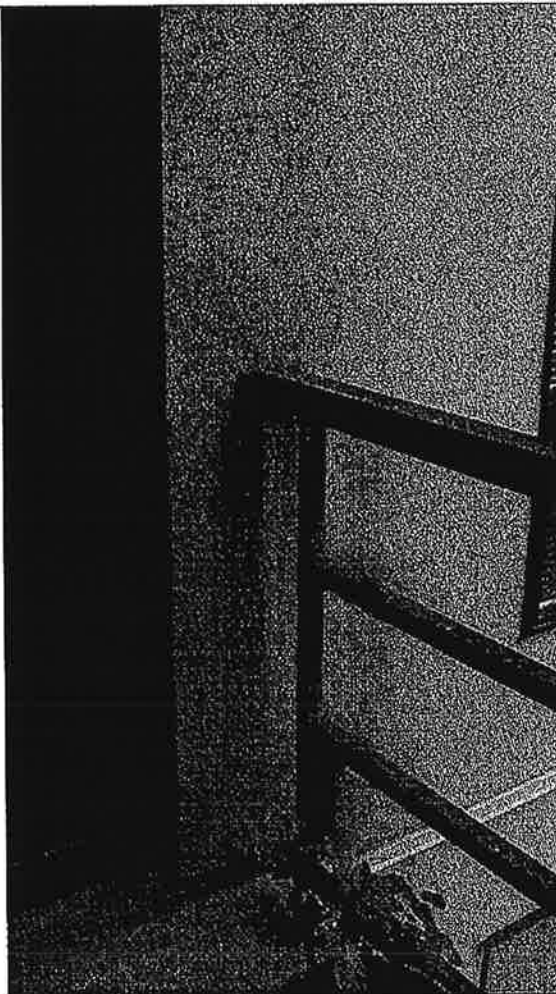
Photo 30

- The vinyl membrane is curling back along the perimeter of the balcony in one location on the South elevation (Photo 25)
- Cuts and split membranes were noted in a few locations allowing water direct access to the plywood substrate (Photos 26-27)
- A diverter angle flashing has been installed to minimize rainwater runoff onto the building façade. However, the Owners should consider having gutters installed around all balconies to manage all surface runoff and minimize organic build-up on the balconies below (Photos 28-29)
- Staining and organic build-up was present on some balconies. Most balconies appeared to be cleaned periodically. The accumulation of debris and organic build-up can negatively affect the performance of the membrane (Photos 30-32)

- Replace all balcony membranes.
- Replace damaged balcony framing and plywood at balcony decks as required ensuring a positive slope away from the building.
- Install a 60 mil vinyl membrane system returning vertically eight inches and over door sills on balcony locations.
- Rectify any structural issues (during a repair process) that may exist on balcony areas.
- Remove and reinstall all existing face mounted guards.
- Option: install new gutter and downspout system to every balcony.

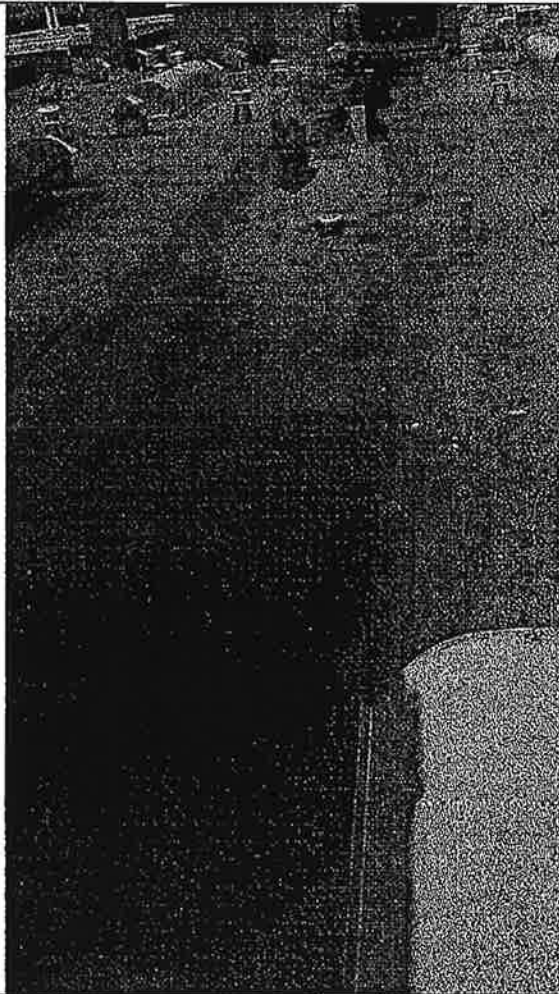
Photo 33

- The roof appears to be adequately sloped to a central drain, however stagnant water has built-up due to a clogged strainer on the drain (Photos 33-34)

- The roof should be inspected and maintained on a regular basis.
- Clear roof drain strainer of debris on a regular basis.
- Remove all moss build-up on membrane surfaces on a semi-annual basis.
- Remove and replace 2x4 supporting HVAC unit with pressure treated wood or neoprene pads.
- Repair roof vent insect screens were necessary
- Repair bare spots missing granular on the SBS cap sheet
- Remove all roof scuppers and install new with improved detailing.
