# 2011 Depreciation Report

West Royal, 328 Taylor Way, West Vancouver, BC

PROJECT # 5185.00  
DATE August 23, 2012

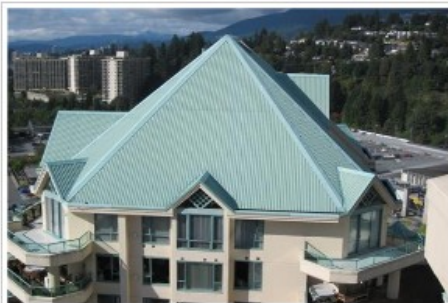
Encl 02

**Location:** Main roof level for both towers and townhouse turret roofs.  
**Description:** Standing seam roof panels over furring channels on structural steel framing. The roof panels are made from sheet steel with a painted coating. Townhouse roof turrets replaced 2009.  
**Chronological Age:** 20                      **Service Life:** 40  
**Effective Age:** 20                      **Remaining Service Life:** 20  
**Outstanding Conditions:** 0

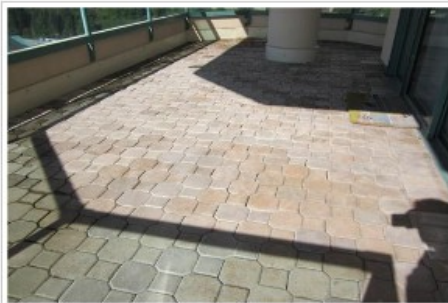
Encl 03

**Location:** Tower and townhouse decks.  
**Description:** 2-ply SBS membrane overlaid with drainage mat, rigid insulation, filter fabric and concrete pavers. The membrane is concealed, and fully bonded to the substrate. Replacement of the existing deck membrane has been carried out at various tower units over the past 4 years. Replacement of the townhouse main roof deck was completed in 2009  
**Chronological Age:** 20                      **Service Life:** 25  
**Effective Age:** 20                      **Remaining Service Life:** 5  
**Outstanding Conditions:** 0

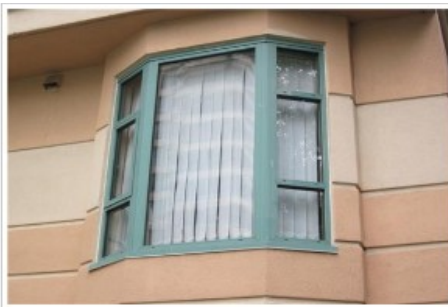
**Encl 10**

**Location:** Townhouses and both towers (floors above main).  
**Description:** Aluminum framed, thermally broken, with double glazed insulated glazing units. Some windows have awning operable vents.  
**Chronological Age:** 20                      **Service Life:** 40  
**Effective Age:** 32                      **Remaining Service Life:** 8  
**Outstanding Conditions:** 0

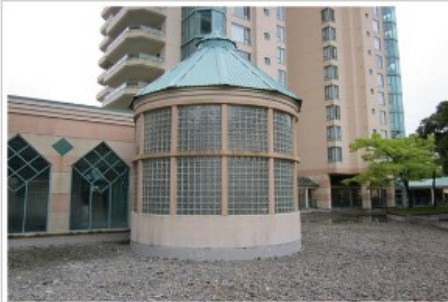
**Encl 11**

**Location:** Townhouses and pool.  
**Description:** Glass block windows with concealed structural framing.  
**Chronological Age:** 20                      **Service Life:** 35  
**Effective Age:** 20                      **Remaining Service Life:** 15  
**Outstanding Conditions:** 0

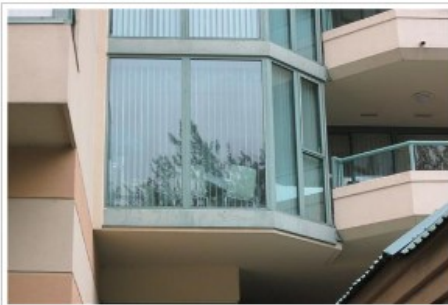
**Encl 12**

**Location:** East and west tower solariums.  
**Description:** Aluminum framed window wall with double glazed insulated units.  
**Chronological Age:** 20                      **Service Life:** 40  
**Effective Age:** 20                      **Remaining Service Life:** 20  
**Outstanding Conditions:** 0

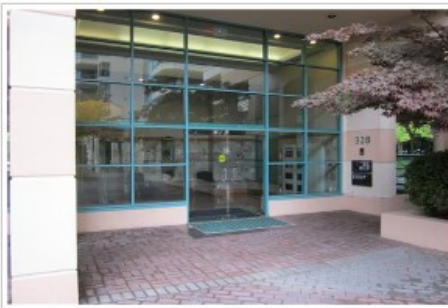
**Encl 14**

**Location:** Lobby entrances to both towers.  
**Description:** Commercial glazing system with closers, magnetic locks and electric strike.  
**Chronological Age:** 20                      **Service Life:** 20  
**Effective Age:** 15                      **Remaining Service Life:** 5  
**Outstanding Conditions:** 0

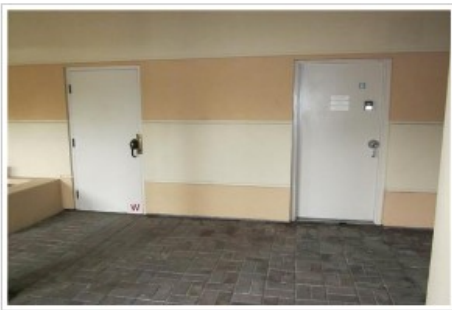
**Encl 15**

**Location:** Building exit doors & service rooms.  
**Description:** Steel frame exterior doors, some with glazing, used for exit doors and service rooms.  
**Chronological Age:** 20                      **Service Life:** 25  
**Effective Age:** 16                      **Remaining Service Life:** 9  
**Outstanding Conditions:** 0

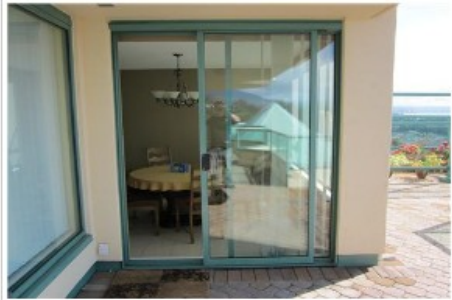
**Encl 16**

**Location:** Balconies, decks & patios.  
**Description:** Aluminum framed sliding exterior doors with insulated glazing units.  
**Chronological Age:** 20                      **Service Life:** 20  
**Effective Age:** 12                      **Remaining Service Life:** 8  
**Outstanding Conditions:** 0

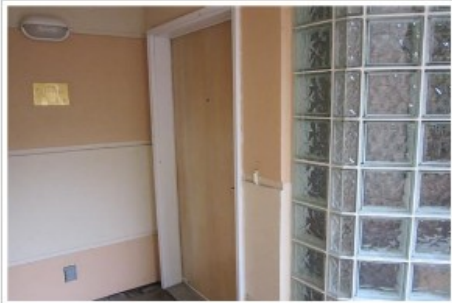
**Encl 17**

**Location:** Townhouses.  
**Description:** Protected entrance doors and casings with coatings for protection against weather exposure.  
**Chronological Age:** 20                      **Service Life:** 25  
**Effective Age:** 20                      **Remaining Service Life:** 5  
**Outstanding Conditions:** 0

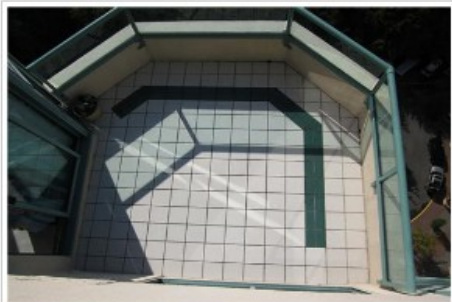
**Encl 18**

**Location:** Balconies.  
**Description:** Concrete slabs overlaid with ceramic tiles on thin set mortar bed.  
**Chronological Age:** 20                      **Service Life:** 30  
**Effective Age:** 20                      **Remaining Service Life:** 10  
**Outstanding Conditions:** 0

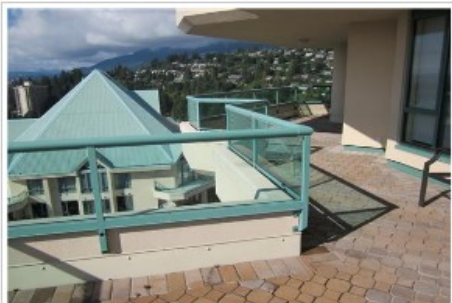
**Encl 19**

**Location:** Decks & balconies  
**Description:** Glass and metal frame deck & balcony guardrails.  
**Chronological Age:** 20                      **Service Life:** 40  
**Effective Age:** 20                      **Remaining Service Life:** 20  
**Outstanding Conditions:** 0

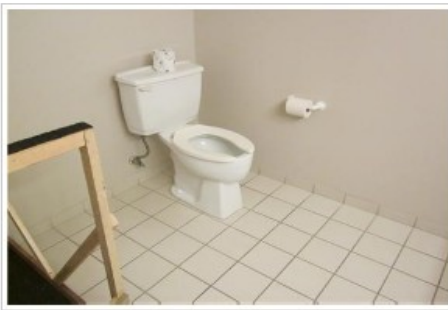
**Mech 06**

**Location:** Amenity room m/f washrooms, pool change rooms & corporate suite.  
**Description:** Ceramic wall hung urinals and floor mounted toilets.  
**Chronological Age:** 20                      **Service Life:** 30  
**Effective Age:** 20                      **Remaining Service Life:** 10  
**Outstanding Conditions:** 0

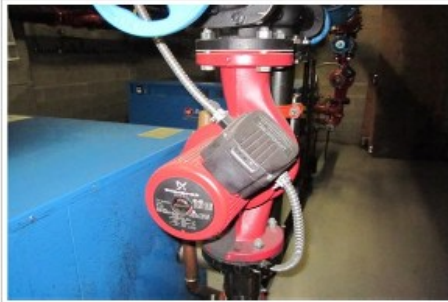
**Mech 07**

**Location:** P1 boiler room, valve room, sprinkler room & rooftop mechanical rooms.  
**Description:** Grundfos, Armstrong & Taco 1/6, 1/4, & 1/2hp hot water re-circulation pumps.  
**Chronological Age:** 3                      **Service Life:** 8  
**Effective Age:** 3                      **Remaining Service Life:** 5  
**Outstanding Conditions:** 0

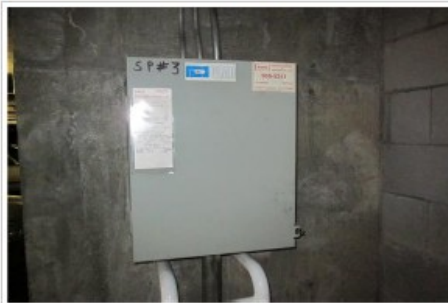
**Mech 08**

**Location:** P1 stall 337 (simplex), Storage 1 (simplex), P2 stall 3 (duplex), P2 stall 126 (duplex)  
**Description:** Zollar & Myres ,simplex and duplex systems, 1 hp, with PLAD cotrollers sump pump systems for storm and sanitary.  
**Chronological Age:** 20                      **Service Life:** 15  
**Effective Age:** 14                      **Remaining Service Life:** 1  
**Outstanding Conditions:** 0

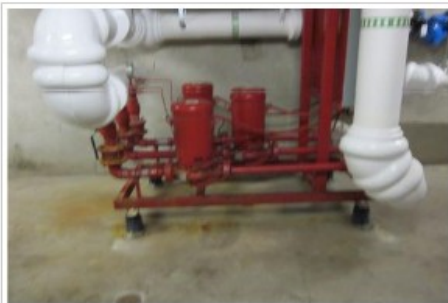
**Mech 09**

**Location:** P1 Valve room.  
**Description:** Armstrong, model 4380 BF-STD booster pump system with three vertical 10 HP pumps, bronze and stainless steel construction, & Siemens controller unit to supply constant boosted pressure to fixtures and equipment on all levels.  
**Chronological Age:** 3                      **Service Life:** 14  
**Effective Age:** 3                      **Remaining Service Life:** 11  
**Outstanding Conditions:** 0

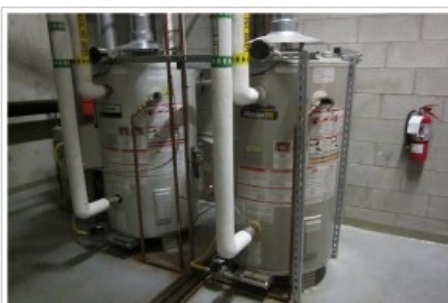
**Mech 10**

**Location:** East tower rooftop mechanical room.  
**Description:** Gas fired domestic water heaters to supply hot water to the upper floors of the east tower.  
**Chronological Age:** 5                      **Service Life:** 12  
**Effective Age:** 5                      **Remaining Service Life:** 7  
**Outstanding Conditions:** 0

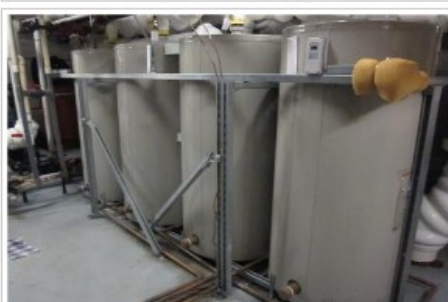
**Mech 11**

**Location:** Sprinkler room, rooftop mechanical rooms,  
**Description:** A.O Smith (model TJV 120) 120 gallon tanks, hot water storage tanks connected to domestic boiler system.  
**Chronological Age:** 3                      **Service Life:** 8  
**Effective Age:** 3                      **Remaining Service Life:** 5  
**Outstanding Conditions:** 0

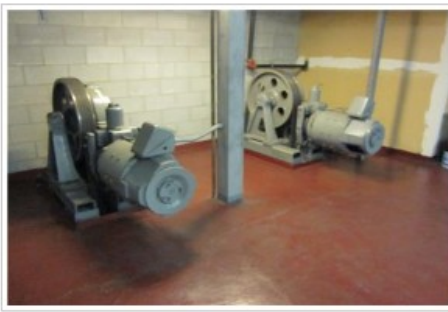
**Elev 01**

**Location:** East and west towers.  
**Description:** Geared top mount traction elevators with Northern Elevators Limited controls, 25 & 30 hp (AC/DC) drives & Imperial geared machines.  
**Chronological Age:** 20                      **Service Life:** 25  
**Effective Age:** 20                      **Remaining Service Life:** 5  
**Outstanding Conditions:** 0

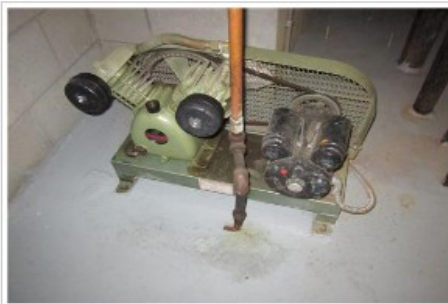
**Fire 03**

**Location:** Sprinkler room.  
**Description:** Swan compressor, model SVU 101, with 1 HP motor and 225 l/min. capacity to increase the pressure of air in the fire sprinkler lines.  
**Chronological Age:** 20                      **Service Life:** 14  
**Effective Age:** 14                      **Remaining Service Life:** 0  
**Outstanding Conditions:** 0
